GigaCrete Testing Presentation
8/23/2016

A new Eco-Friendly direction for coatings in North America

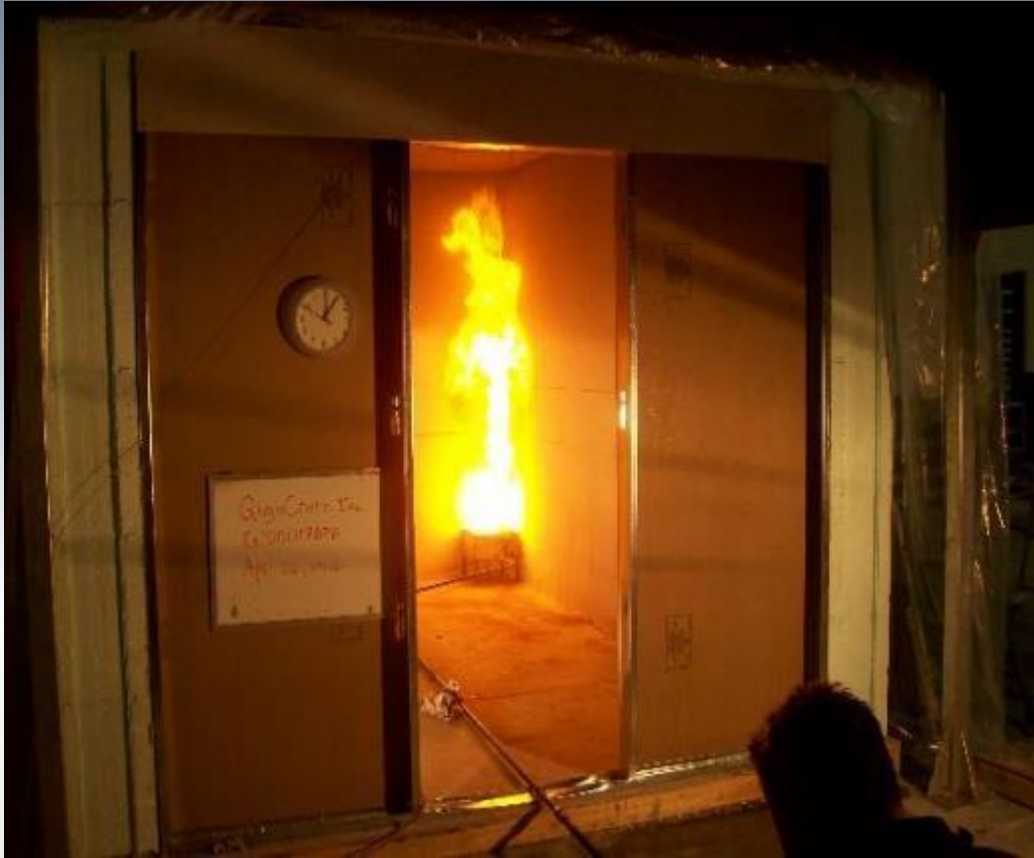
PlasterMax was tested to NFPA 286 a 15 minute Corner Burn Test at 1,400 degrees F as a Gypsum Board replacement over EPS foam.

PlasterMax passed at 1/8" thick and exhibited zero smoke or combustion

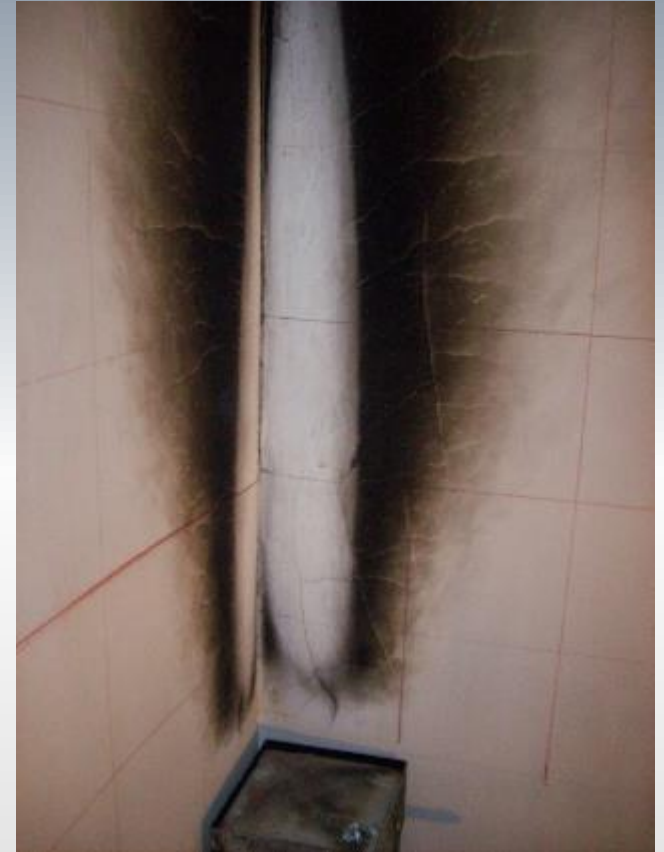
GigaLab internal fire test simulating ASTM-E119, 1 hour, 2 hours & 4.25 hours
Exterior assembly fire test

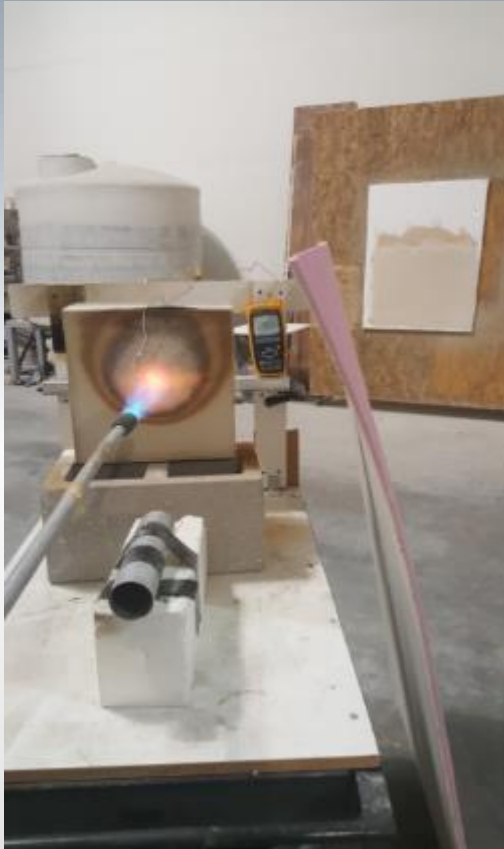
1,700 F flame directly on StuccoMax (E119 does not have direct contact)

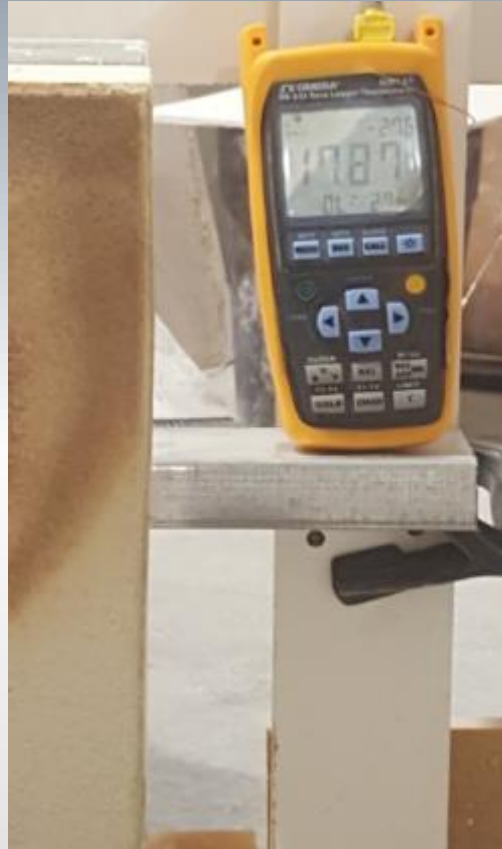
1,797 F registered on thermocouple

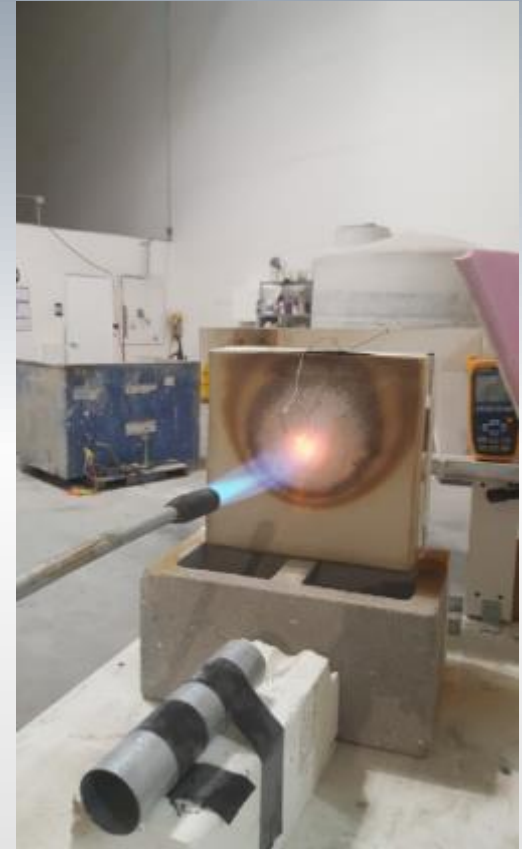
StuccoMax glowing white hot

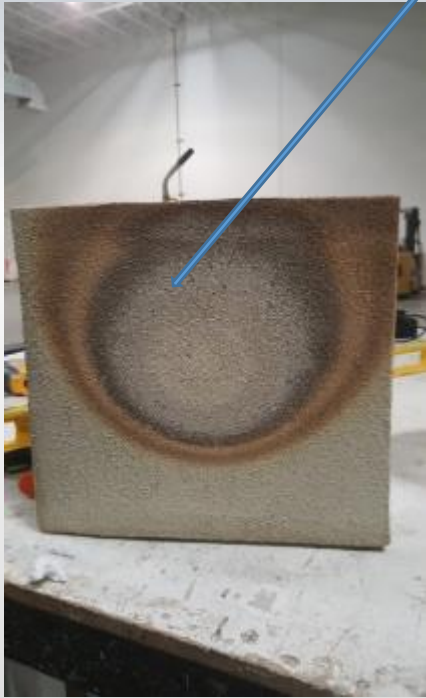
One hour test using StuccoMax, GigaFoam, EPS core, PlasterMax interior finish

StuccoMax face

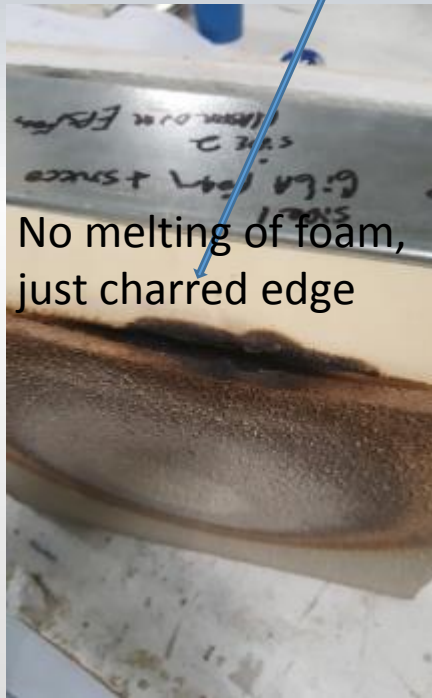
Top view

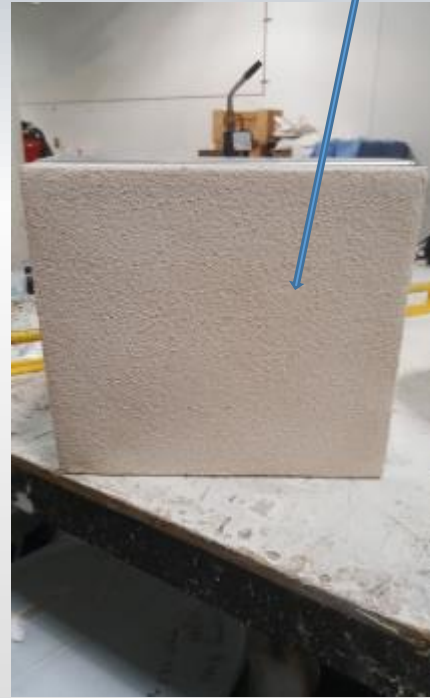
Interior PlasterMax finish
Zero damage

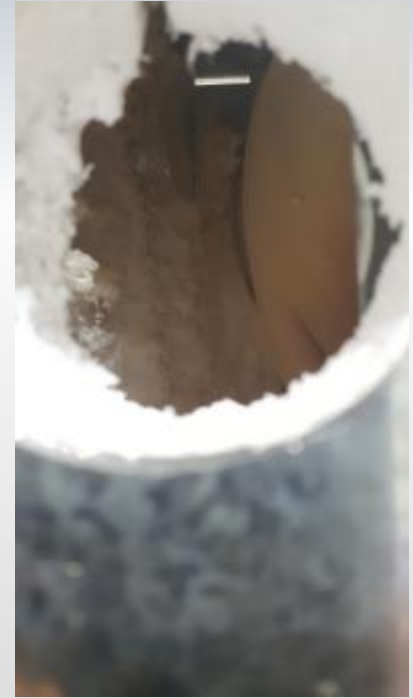
Cavity inside wall showing where EPS foam melted but GigaFoam stayed intact

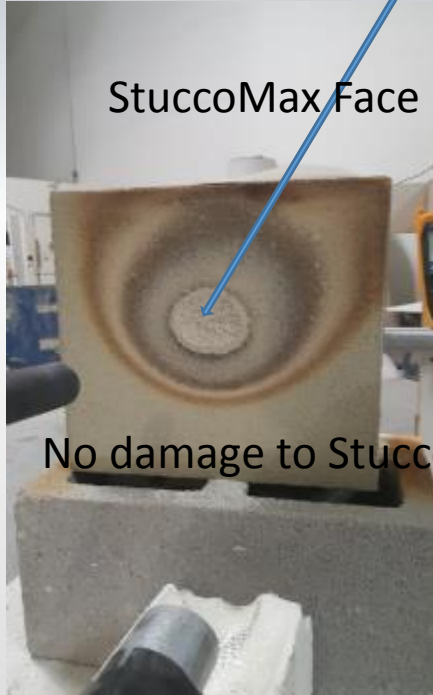
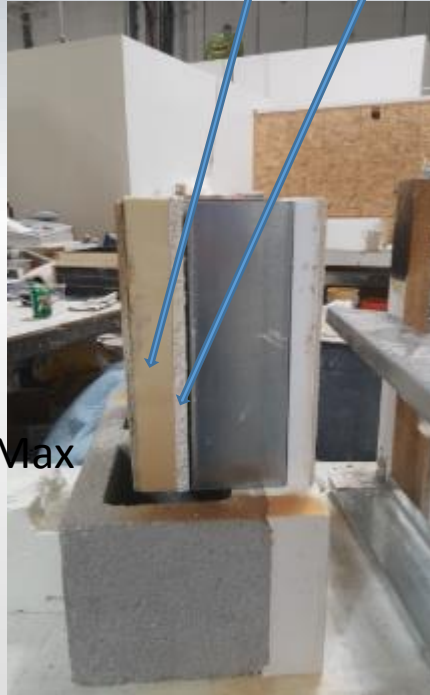
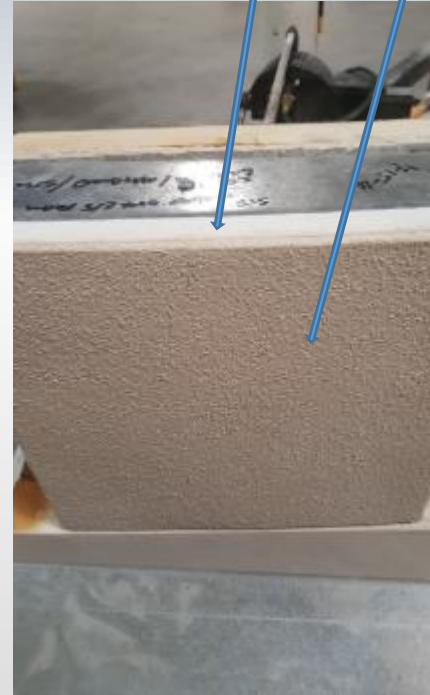
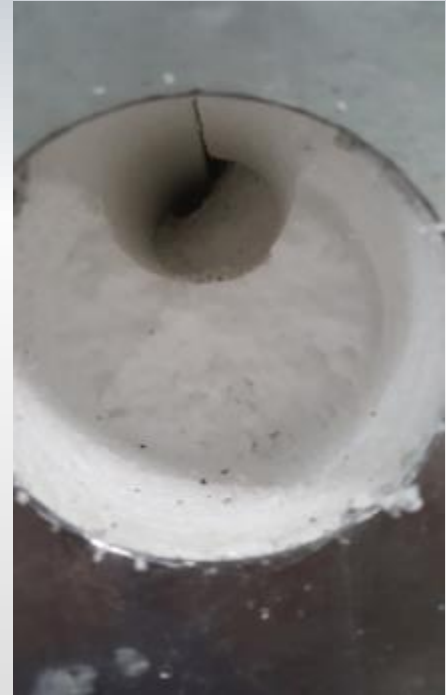
Two hour test using StuccoMax, GigaFoam, GigaBoard, EPS core, PlasterMax interior finish

StuccoMax face

Side view

Interior PlasterMax finish Zero damage, only warm to the touch.

Cavity inside wall showing where foam remained intact, melting slightly

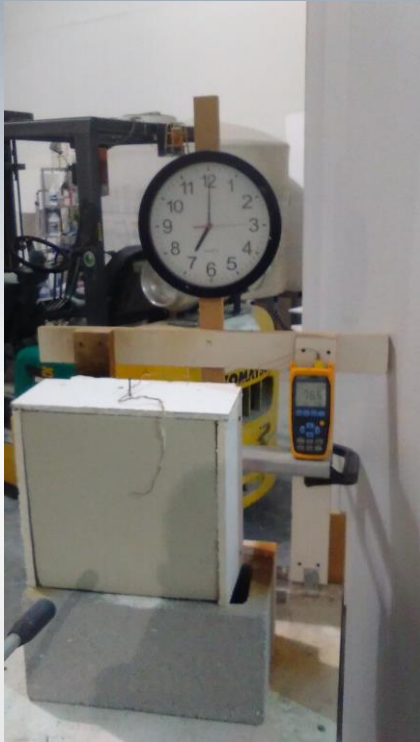
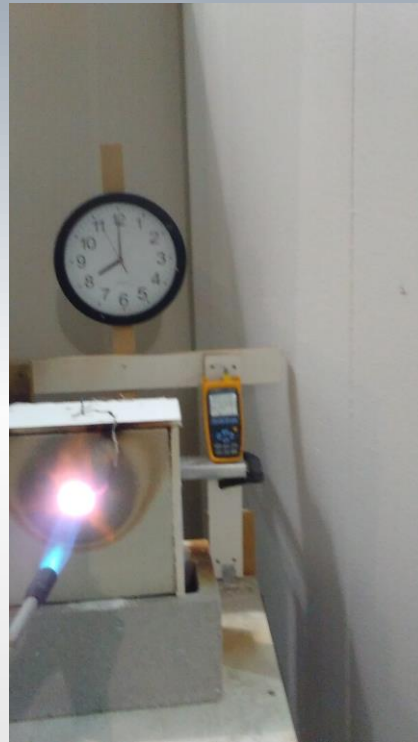
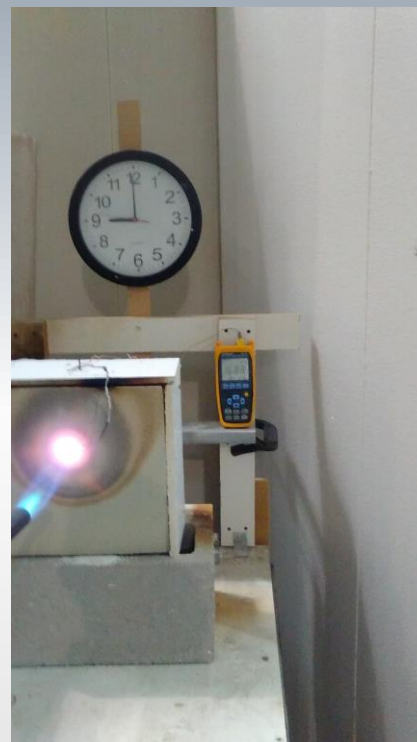
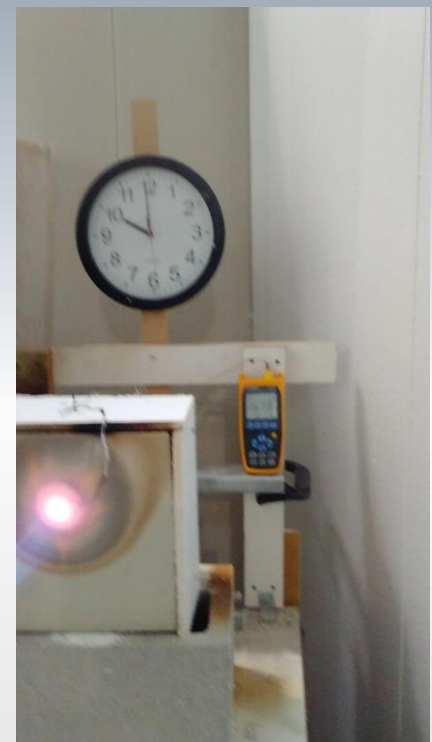
Four hour test using StuccoMax, GigaFoam, GigaBoard, EPS core, PlasterMax interior finish

7am start time

1 hour

2 hours

3 hours

Propane torch ramps up to 1,700 F surface temperature within a few minutes
Note Thermocouple wire connected to meter .

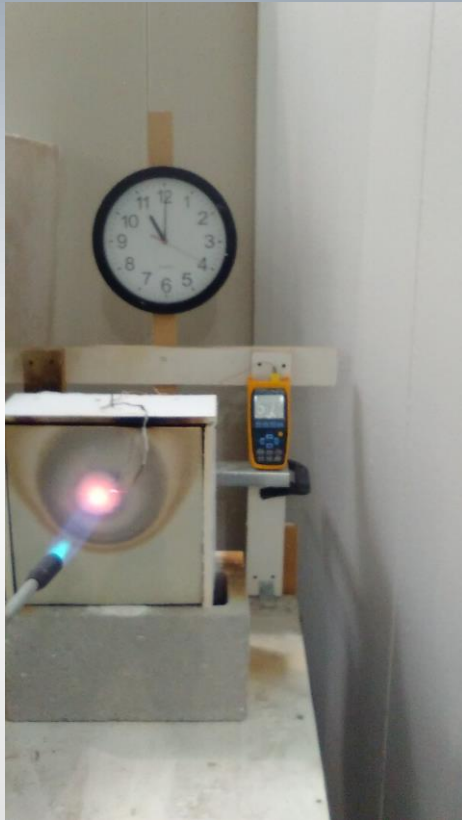
4 hours

Four hour test using StuccoMax, GigaFoam, GigaBoard, EPS core, PlasterMax interior finish

Started at 7am, time below is 11am, test actually ran additional 20 minutes

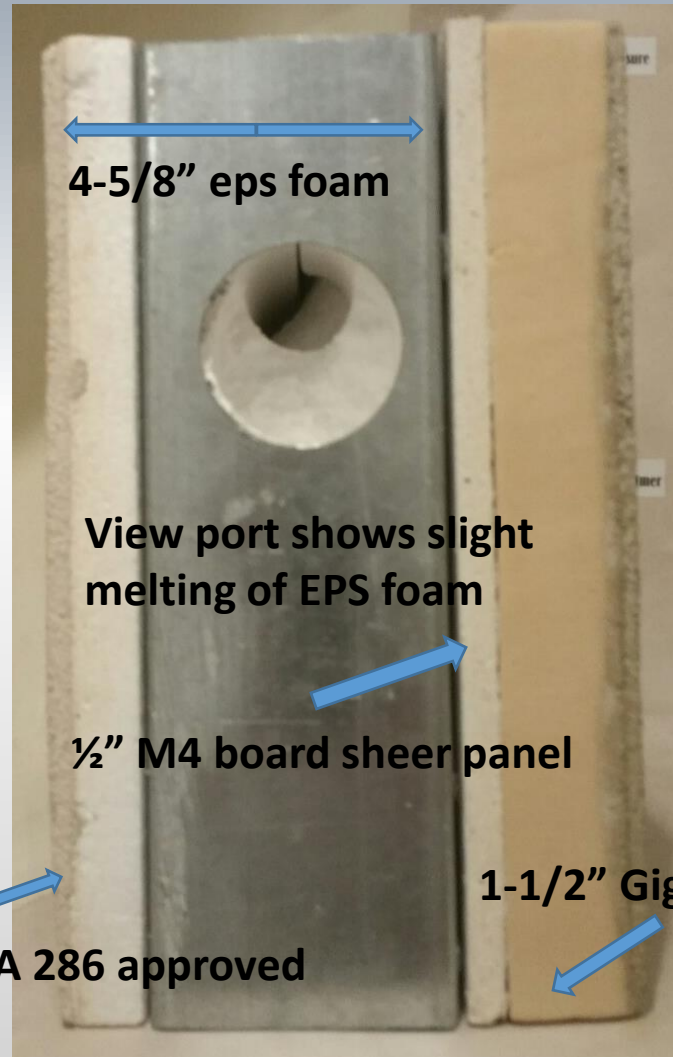
4-5/8" eps foam

View port shows slight melting of EPS foam

1/2" M4 board sheer panel

1-1/2" GigaFoam + 3/16" StuccoMax

3/16" PlasterMax NFPA 286 approved

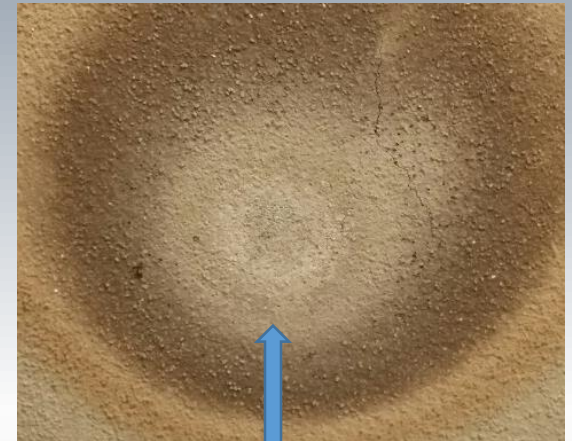
Surface damage only
No penetrations
Small cracks even
after 4 hours and 20
mins @ 1,700 F

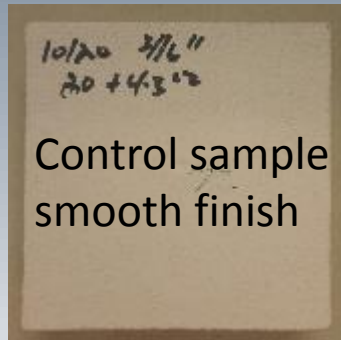
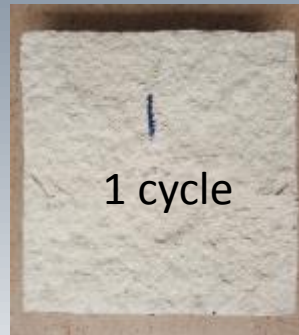
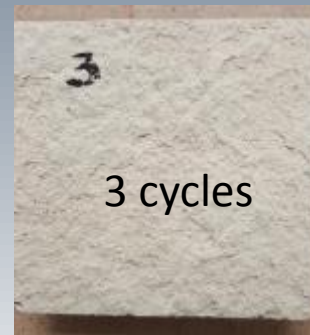
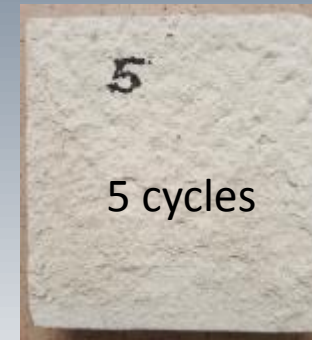
Weathering tests done with modified ASTM C1202 test in Maytag Dishwasher
Simulating wind driven rain, extreme humidity and extreme heat.

STO, DRYVIT, SENERGY, PAREX samples subjected to Dishwasher test: ASTM C1202
Each sample exhibited severe damage at 1 cycle, 30% loss at 3 cycles and 50% loss at 5 cycles

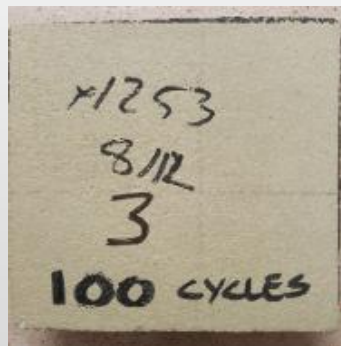
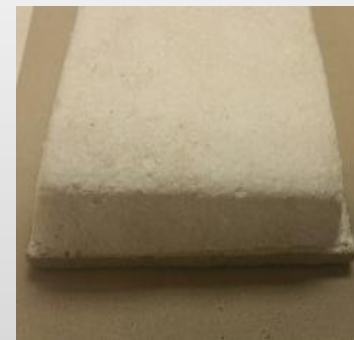
StuccoMax cycled **100 times** plus **40 Freeze Thaw cycles** at -20C with no deleterious effect including bond to EPS foam.

Front side

Edge

Back side

Note:
foam is shrinking
from heat, but
bond to foam is
unaffected.

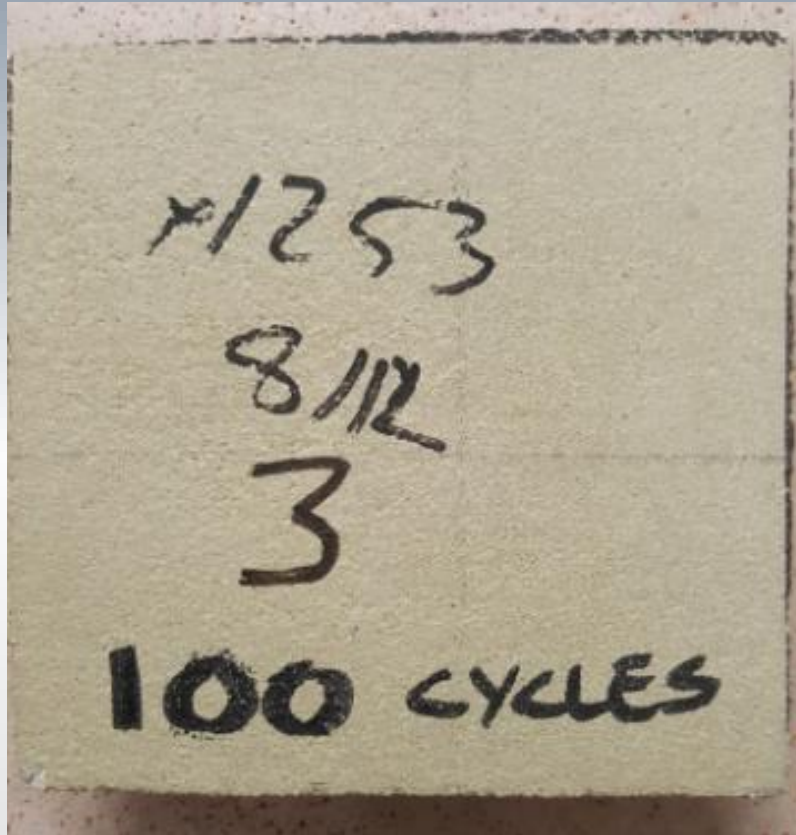
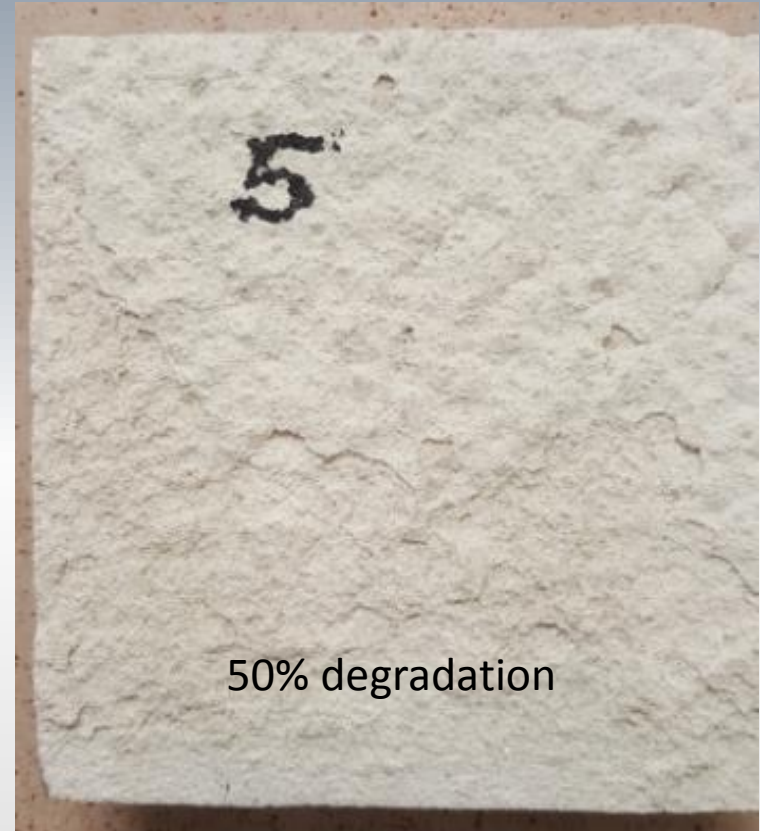
**Blown-up comparisons between StuccoMax and STO, Dryvit, Senergy and Parex.
All have been tested and all react the same.**

StuccoMax remains firmly bonded to the EPS foam
Even after 100 cycles followed by 40 freeze thaw cycles.
Nothing else exists in the stucco industry to compete.

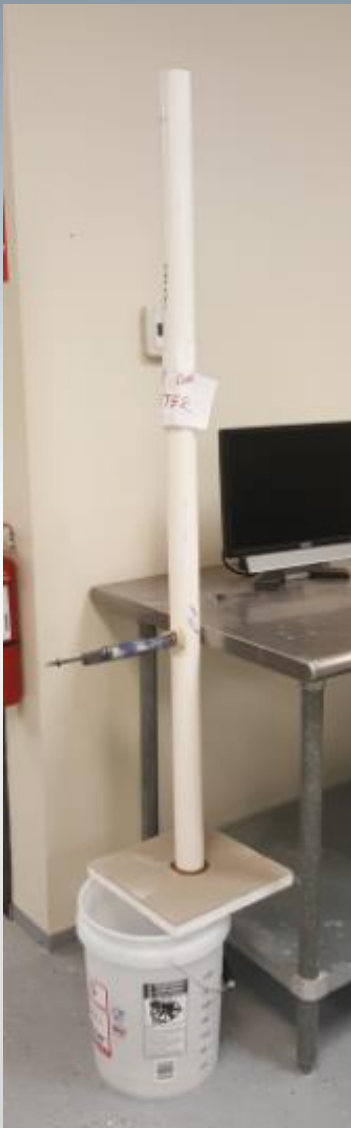
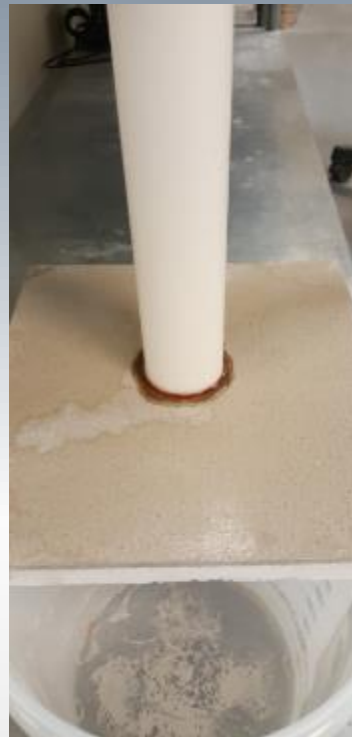
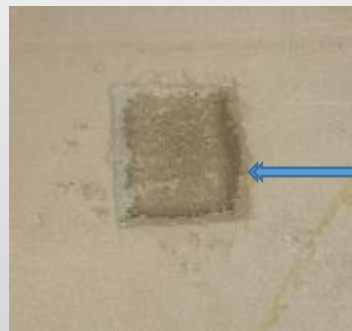
ASTM 60" water column test

Column is epoxied to the StuccoMax over 1" low density 0.90lb EPS foam and filled with 60" of head pressure. Substrate foam is removed beneath water column to see if water droplets or penetration occurs.

Test as seen in photo is 5 years old with NO water penetration!

NOTE: EPS foam is removed on underside exposing back side of StuccoMax

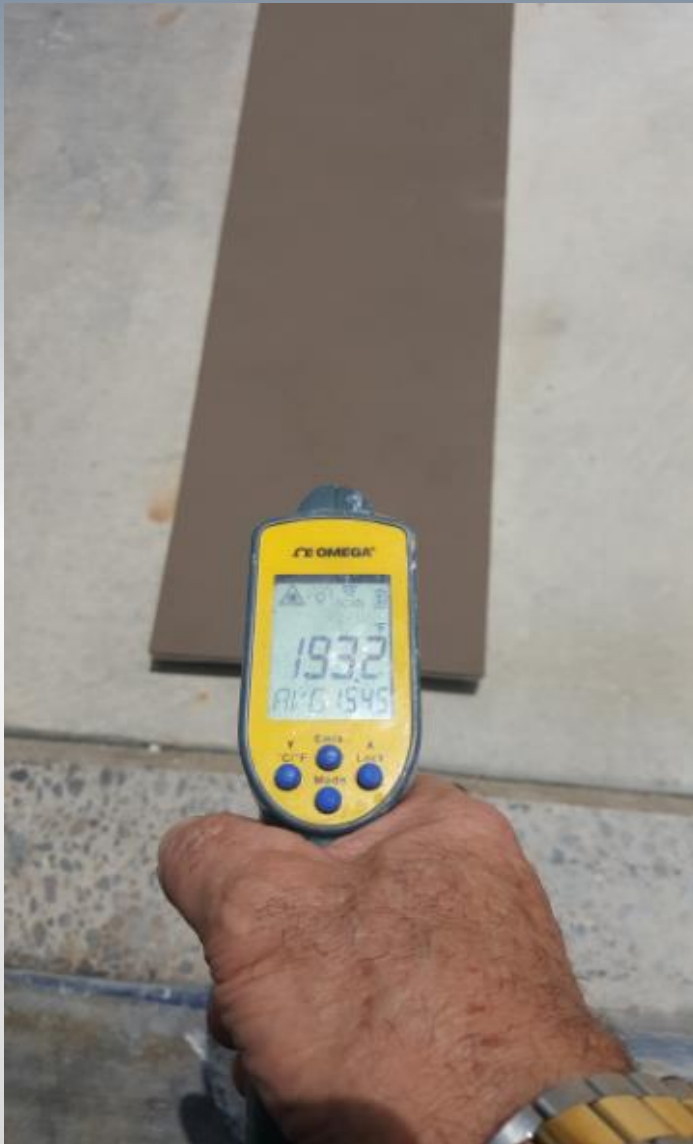
In the hot Las Vegas sun most synthetic stucco applications have to be light in color due to the excessive heat build up and potential delamination issues.

StuccoMax with a dark brown paint and exposed it to direct sunlight with an ambient July temperature of 115F. The sample was laid down on the concrete driveway registering 140F.

As you can see the sample reached a surface temperature of 193.2 degrees with no delamination or bond separation.

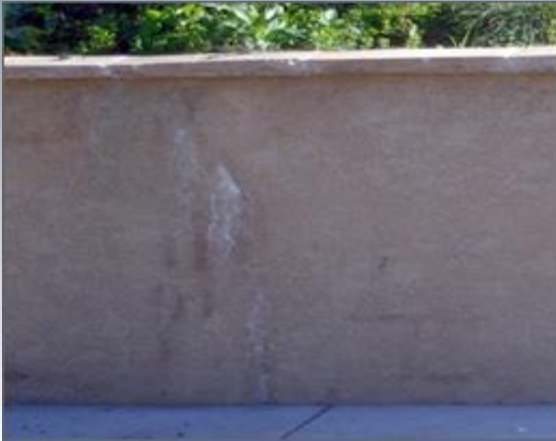
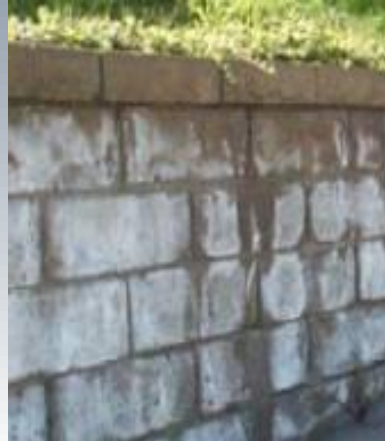
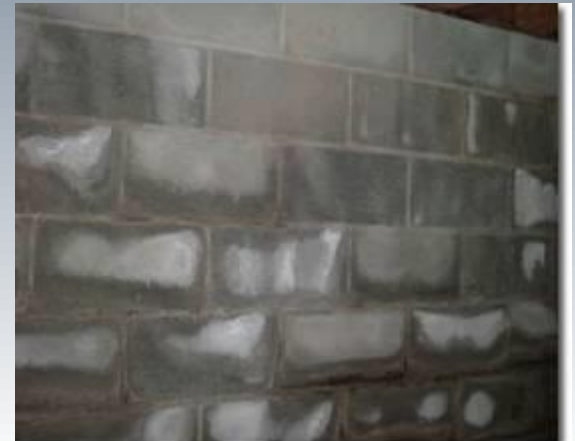
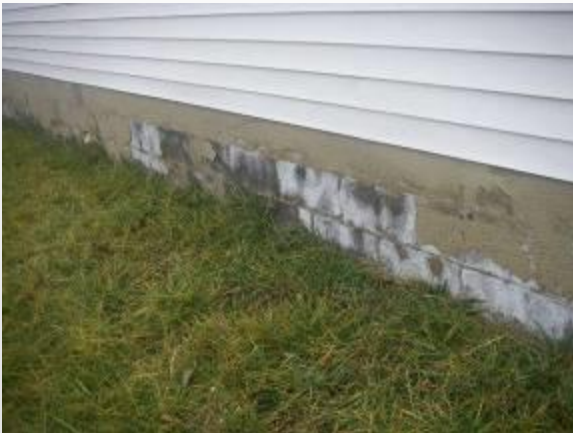
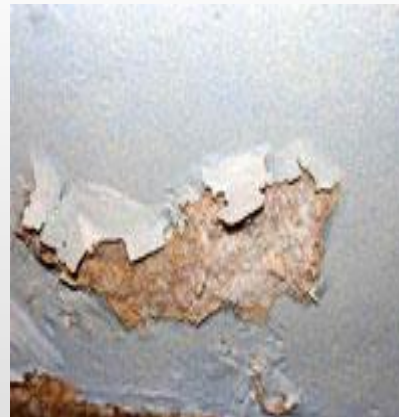
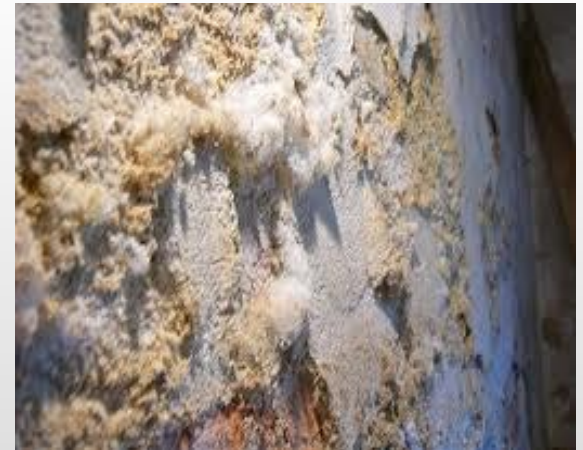
Efflorescence can be a thing of the past. If the wall was first covered with waterproof StuccoMax, this would never have occurred.

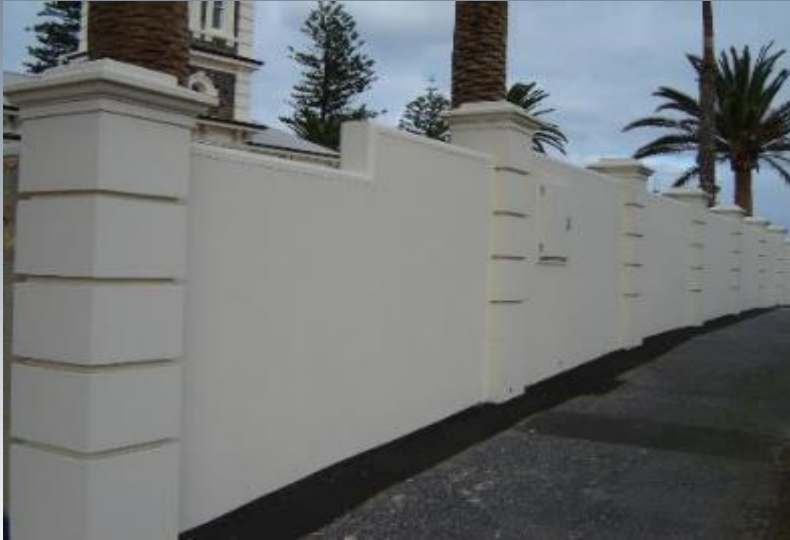
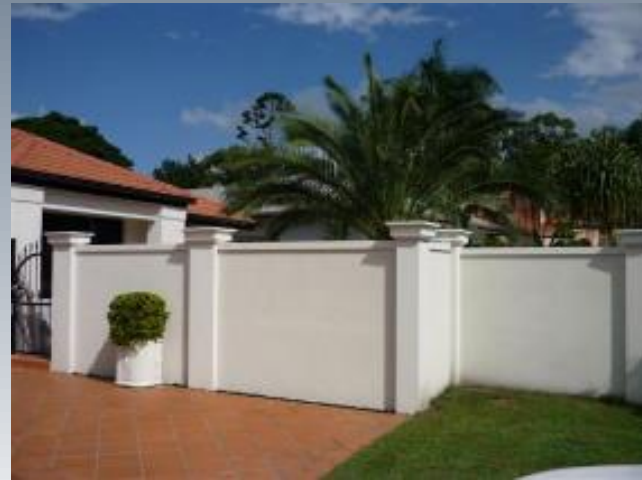
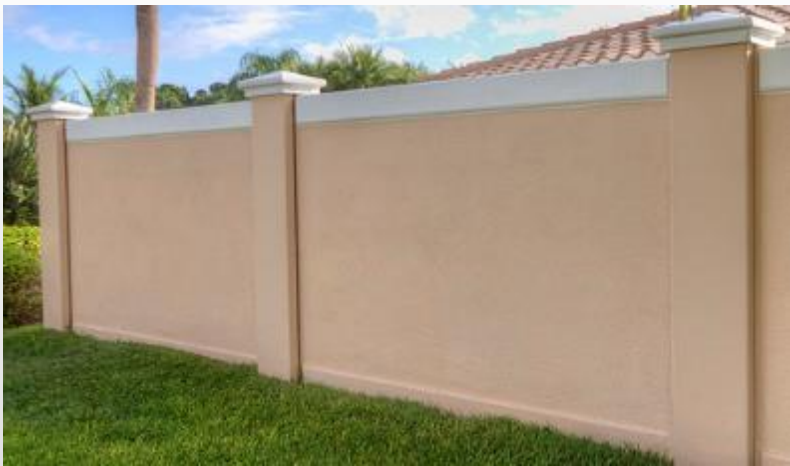
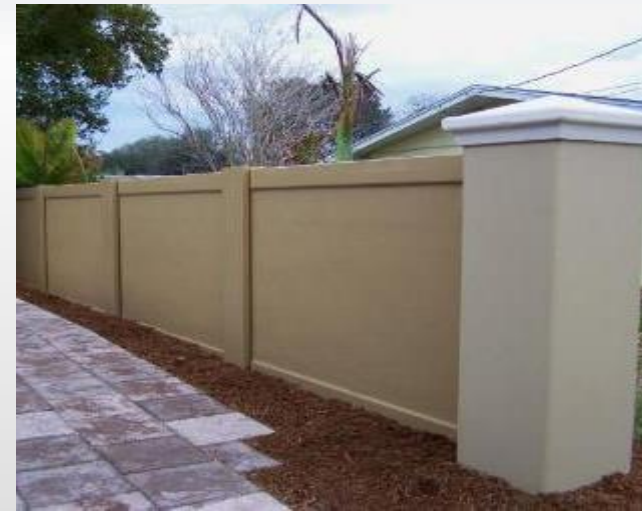
Examples of simple inexpensive fixes to ugly block walls allowing for below grade application

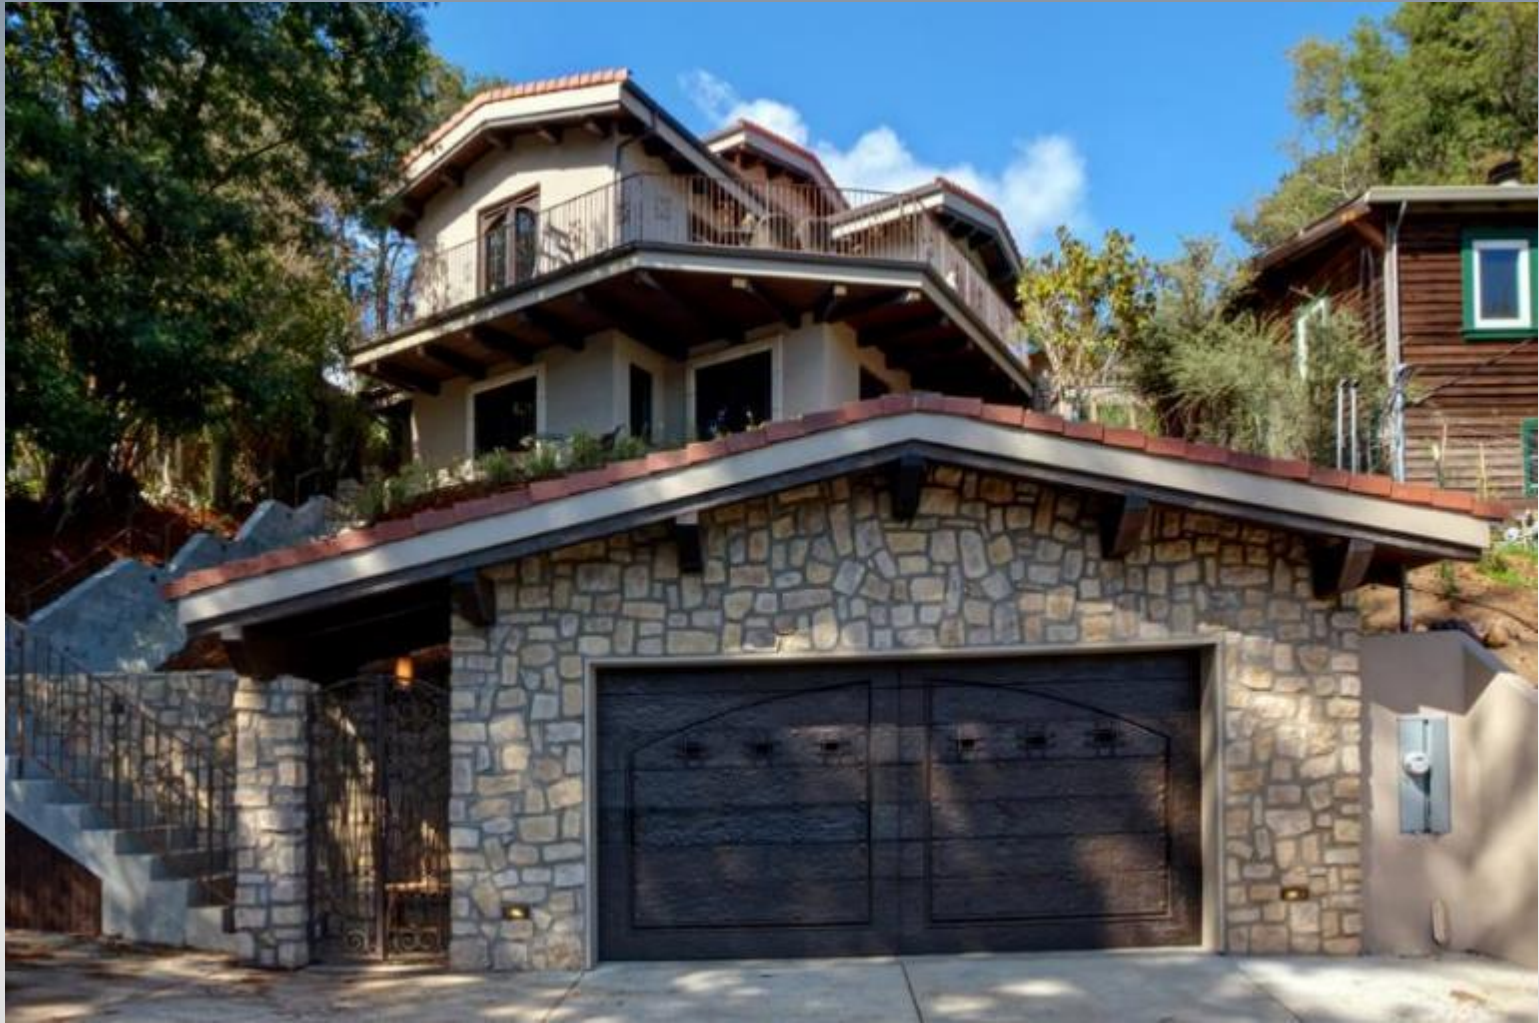
StuccoMax used as exterior stucco, adhesive and grout for stone overlay

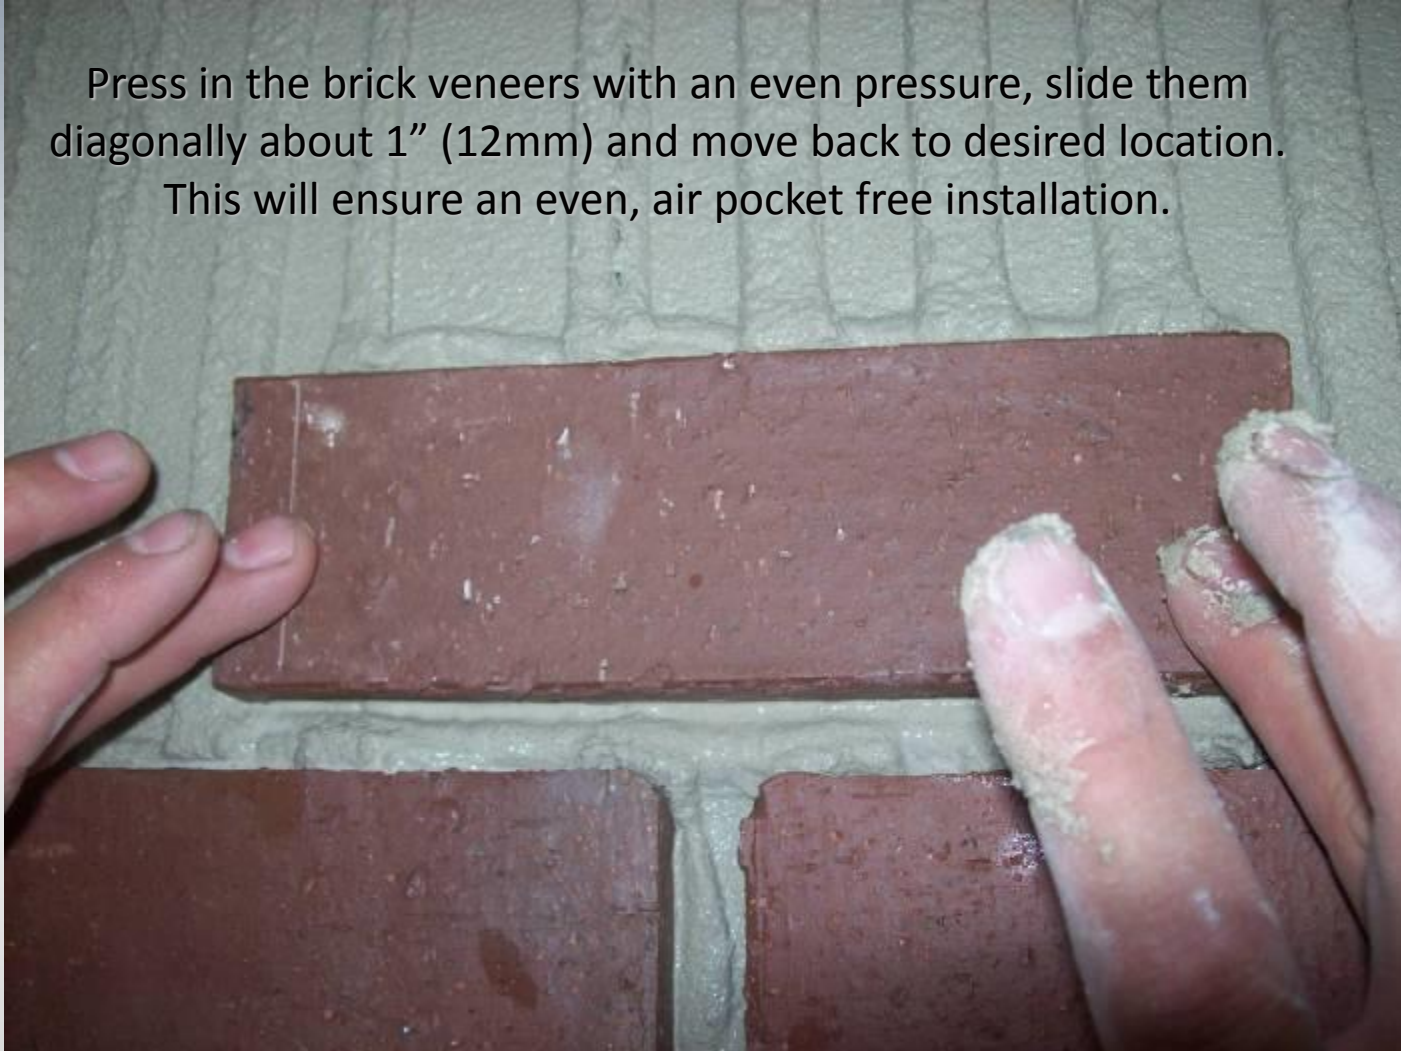
StuccoMax as a superior bonding adhesive, non absorbing, no freeze thaw issues

Press in the brick veneers with an even pressure, slide them diagonally about 1" (12mm) and move back to desired location. This will ensure an even, air pocket free installation.
